IC 735 No RF Output Fault

By G8MNY

(Update Jan 15)

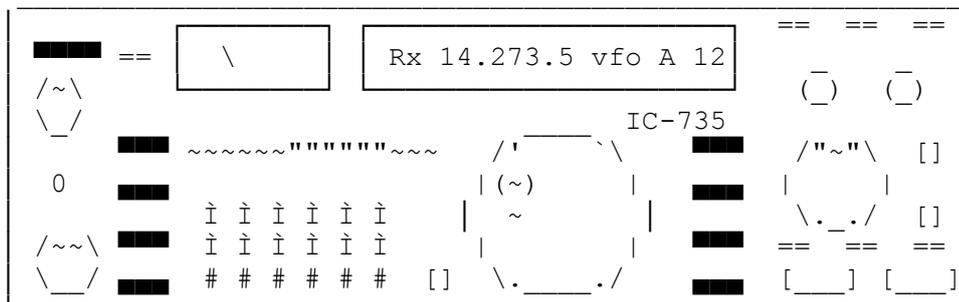
Indicating clues to this fault's whereabouts, were the rig's O/P SWR meter showing power & infinite SWR (internal protection SWR/over Current ALC cuts power back to a safe level) but external kit showed no power.

Initially it looked like it was something to do with the rig's rear Rx phono patch lead as it came & went with any movement in that area. But it turned out to be the nearby SO239, where the centre pin is allowed to float slightly to make good connections. The thin hard wire used in the PA box to the filter PCB had eventually fractured due to this small movement.

- 1/ Remove power lead, remove top & bottom covers including the anti rattle 4 around the LS.
- 2/ Unscrew the 4 screws for PA unit, remove external Phono Rx patch lead, release LS lead, RF drive lead from underside PCB & 2 other connectors to the upper PCB. then rotate the PA unit.
- 3/ Remove all the screening plate screws & lift it.
- 4/ Inspect the aerial socket. If broken as mine was or loose in PCB continue, or go to 8/.
- 5/ Remove the filter PCB (loads more screws) unsolder Rx phono wire & earth.
- 6/ Replace the hard wire link with fine flexible multi-strand wire. (I kept the original insulation tube)
- 7/ Put back the PCB & solder up, check the slight SO239 pin movement will not break the new wire.
- 8/ Reassemble & test.
