MEDUSA SIP2300 Generator Repairs

By G8MNY

My MEDUSA SIP2300 4 stroke petrol generator, had done many years service, but recently packed up while /P.

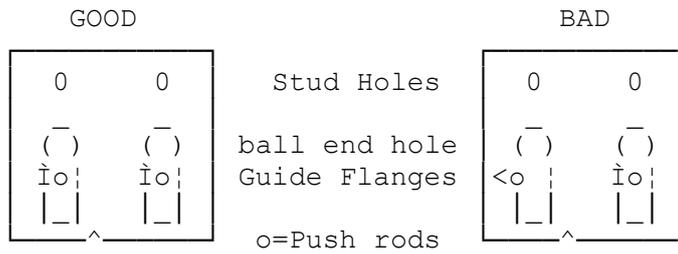
PUSH ROD GUIDE PLATE

Discussing these symptoms with other engine experts, I got all sorts of bad diagnoses. Myself I thought it could be a broken ring or valve spring. So I started at the cylinder head & took the rocker cover off, the fault was obvious! The exhaust valve rocker was at an angle & only pressing on the spring, not the valve! The cause turned out to be a badly worn through push rod guide plate (thin soft sheet steel).

As there was no wear seen on the push rod, the repair was just to remove the adjusters & rockers, & then 2 studs to extract the plate. Then silver solder in a bass guide bush, drilled out to the push rod size & then filled to make a "U" channel, that should last much longer than a new tin can plate. The push rods are also very rough (like needle files) & needed smoothing to a shine with fine emery cloth.

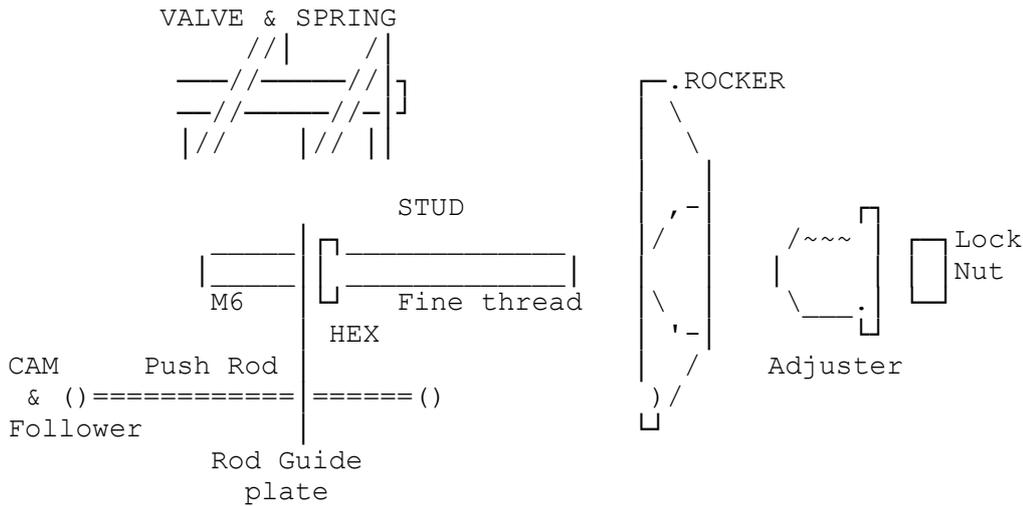
However things are never that simple, & putting back the 6m stud, I managed to strip the thread in the soft aluminium cylinder head casting! :- (This was not all my fault, as the stud hole was much shallower on the exhaust port than the intake, despite the studs being the same length!

I think not cleaning the hole out with a bottoming 6M tap, meant the shallower stud hole filled up with old stud glue (lock tight) stopping the stud from going home, & caused me to strip the casting. After many attempts to get the stud to grip well enough, I gave up, & drilled & tapped it out to M8, & made an M6-M8 adapter sleeve from some steel roding. This worked fine.

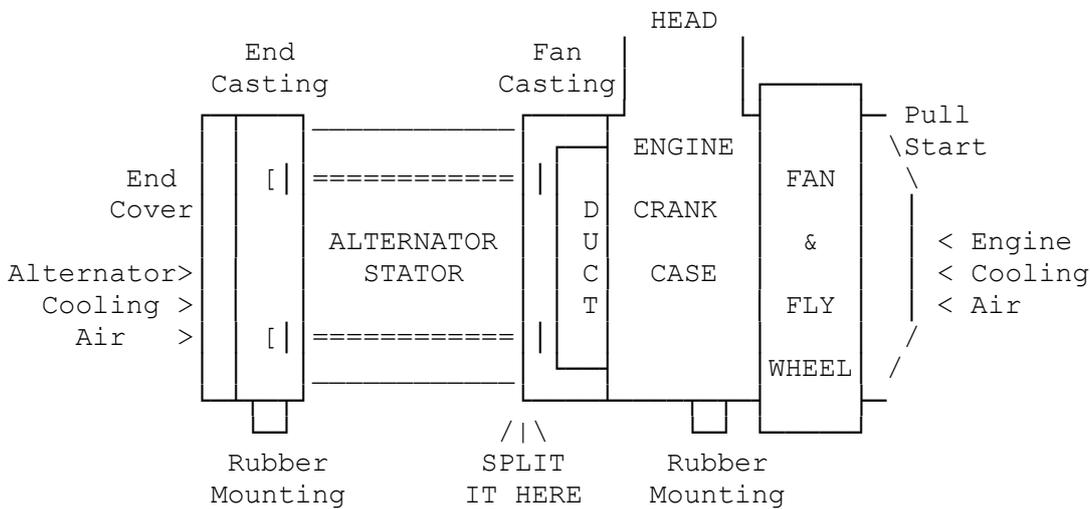
On taking the silencer off for repainting, through the air duct I noticed the black plastic alternator fan was well out of true, & was just at the point of rubbing the casing. I had seen a failed generator where plastic bits were coming out of an air vent & the rotor had all shorted out (over heated no fan?) As my fan is right in the middle of the generator, I needed to split most of the alternator from the engine, something I had not done before on this one, & I had some trouble doing it to get at the fan.

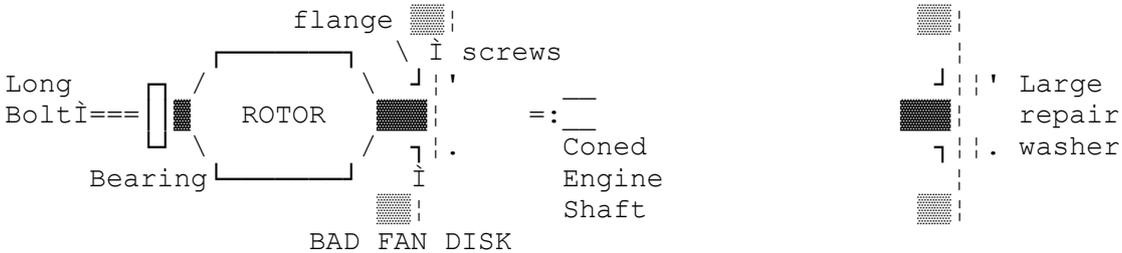
The fan disk is held on to the flange with 2 screws. I found there was no tube spacer/Colette fitted on one of them & the plastic fan had been crushed & slightly split due to this higher pressure. To solve this I made a large washer from 3mm thick aluminium, so the weak plastic fan disk is better supported & kept straighter.

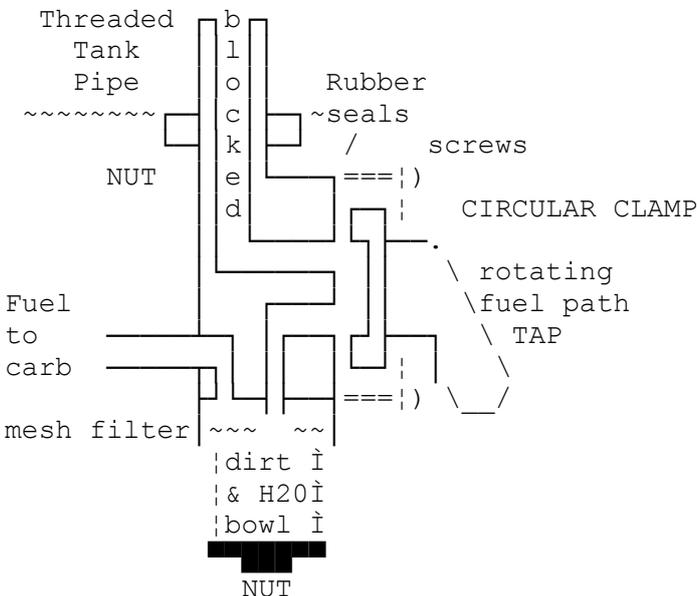
- 1/ Rusted petrol tank (from water in the /P fuel), which eventually holed the tank. I used a phosphoric anti rust paint after 1st doing a test on the petrol cap, that proved petrol had no effect on it. Then after a good clean out & drying, I painted as much of the inside as I could. The pin hole had raised the plastic dipped outer coating. So I scrapped that away & put a plug of really thick Hammerite paint in the hole, & left it a few days to dry & harden. I then redid the anti rust coat inside, & all is now well.
- 2/ Blocked fuel tap, This another consequence of water in the fuel, as the rust particles build up, NOT in the fuel filter trap under the tap, but in the cast pipe feeding the tap! Here I found hand held drills are the best used to clean the pipe.

To remove the tap, you must have less than half a tank of fuel!

Then remove the 2 tank bolts, turn the tap to off & remove the rubber carb pipe.

Now remove & tilt the tank so the tap is clear of the starter case.

Losen the locking nut & unscrew the tap, keeping the tank tilted & fuel at the far end of the tank.
